DEPARTMENT OF ECOLOGY  
INSPECTION REPORT

DATE OF VISIT: July 6, 1989

FACILITY: United Marine Shipbuilding, Inc. T

TYPE OF FACILITY: Shipbuilding/repair

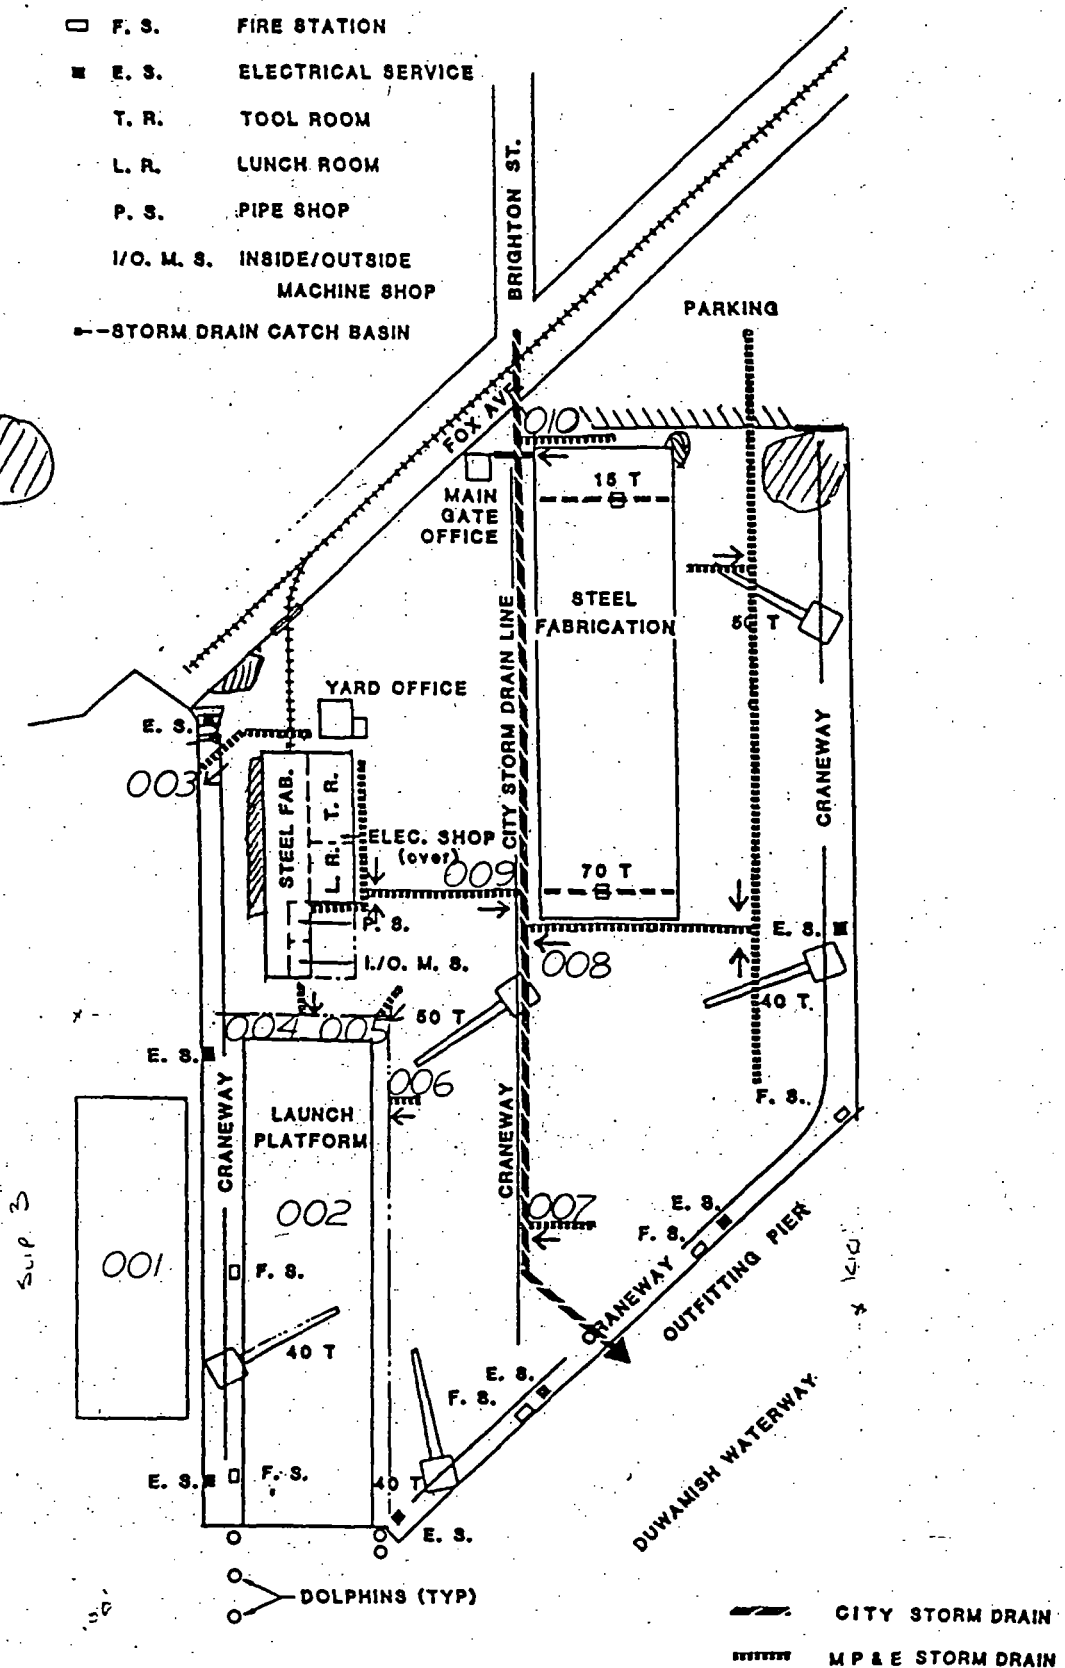
# M P & E YARD LAYOUT

Approximate area of soil contamination
